GEOTECHNICAL ANALYSIS OF CARSINGTON DAM FAILURE

Sukiman *

Abstract

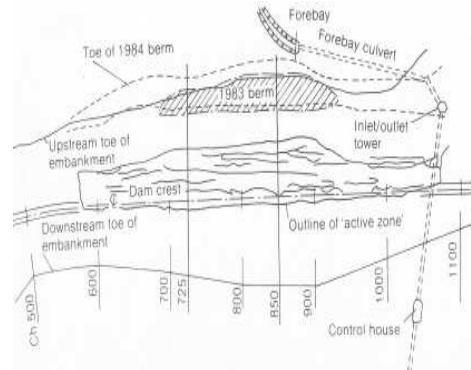
Figure 2. Failure in Carsington Dam at 8 June 1984 (chainage and elevation in meters)

Carsington Dam is located near the village of Hognaston in Derbyshire and has a maximum design height of 35 m. Plan of the Dam is presented in Fig. 1. This Dam was due to finish placing of filling material back in May 1984 when a crack was reported on the dam crest of its upstream part. This crack enlarged and had not stopped until 6 June, with the berm enlargement continued for a few more days. In chainage 675 m, the upstream toe had moved 13 m laterally and had lifted by about 2.5 m in addition of severe disruption of the upstream slope (Fig. 2).

An early exploratory trench at chainage 620 m revealed the slip plane in the base layer and gave some understanding of the distortion at the toe. Further extensive exploratory works in trenches at chainage 720 m and 825 m (Fig. 2) provided more information and allowed sampling of embankment and foundation materials. From survey and interpretation, the geometry of the failure surface was derived and is presented in Fig. 3.

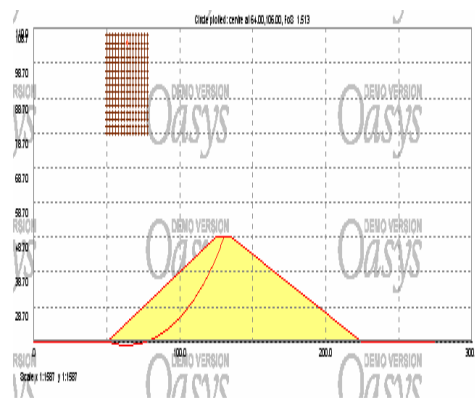
Figure 6. Graphical Output of Slope Stability Analysis (x=49m, y=20m) using **OASYS-SLOPE**

Set	r_u	common point	circle centre	FoS	Comment
1	0.2	A (49, 20)	(62, 112)	1.513	OK
		B (125, 50)	(200,122)	1.771	
	0.4	A (49, 20)	(64, 108)	1.183	needs attention
		B (125, 50)	(200,120)	1.380

0.6	A (49, 20)	(66, 104)	0.855	FoS < 1, failure
		B (125, 50)	(198,114)	0.994	
2	0.2	A (49, 20)	(64, 106)	1.321	Ok
		B (125, 50)	(200,120)	1.532	
	0.4	A (49, 20)	(66, 102)	1.043	needs attention
		B (125, 50)	(198,114)	1.207

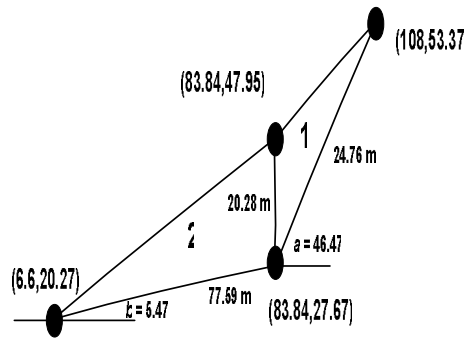
Figure 8. Simplified two-wedge model of the cross section at chainage 725

After several attempts, the most reasonable convergence value of factor of safety was approximately 1.25. Several calculation results are presented in Table 5.

From this simplified analysis, the FoS was approximated to be 1.25. Thus the dam is considered safe against the test values. Although this analysis used many simplifications (e.g. homogenous materials, simplified dimension, etc), it is still representative to describe that the failure which took place in the dam was caused by inadequate material strength and/or higher pore pressure value.

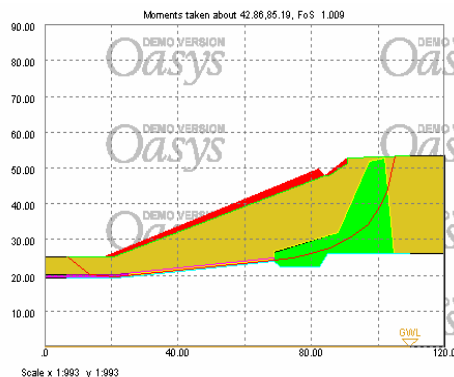
Figure 11. Input Geometry for SLOPE (failure line is highlighted red)

For this analysis, the geometry of the dam was taken from chainage 725 as presented in Fig. 4. The position of the non-circular failure surface was taken from the approximated failure line in Fig. 3. The input geometry for the SLOPE programme is presented in Fig. 11.

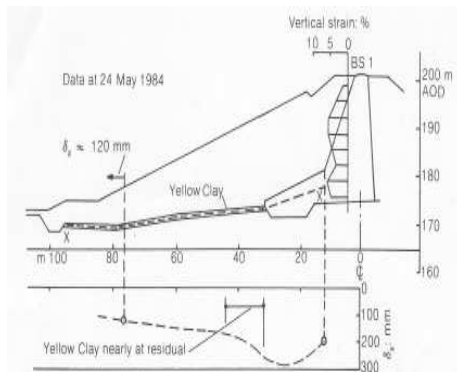
Figure 13. Horizontal movements on line XX and vertical strain in the core (chainage 725)

It is obvious that the strength of the core and boot and the yellow clay 1 are located between their post-peak and residual values and especially the yellow clay 1, it's values is located near it's residual values ($\Phi' = 12^\circ$; $c' = 0$ kPa). This characteristic is relevant to the measured condition of the dam (Fig. 13) in chainage 725 that shows the yellow clay near the boot to be nearly residual.

From this analysis, it can be concluded that the materials in the embankment dam had different conditions. In this case the core and boot material and the yellow clay material (especially near the boot) were estimated to be below their post peak values. This reduction of strength is likely to be the cause of the slope failure.
